COGLEY PROPERTY INSPECTIONS

456 Abc Avenue
Oakland, California
November 10, 2011 - 9:00 a.m.
Report Number 12346-C

This Report Prepared for
Client's Name

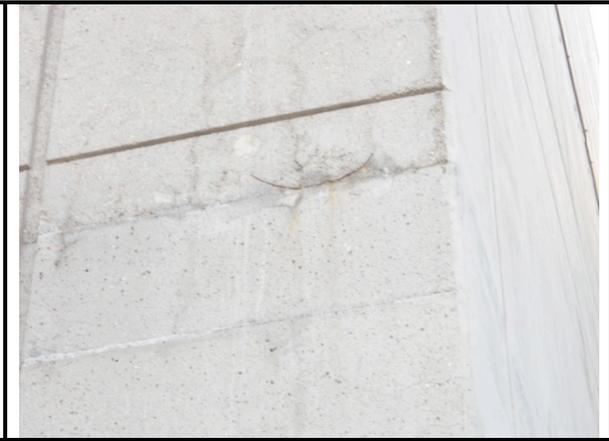
Portions of the exterior surfaces are unpainted concrete. We observed rust stains at the left rear that appear to be caused by rebar that has been exposed to moisture. We recommend this area be monitored and sealed as needed to prevent concrete spalling.

Water-born salts coming in contact with steel reinforcing bars can generate a mild electric current that accelerates oxidation or rusting in the foundation steel. The rusting steel may expand and cause the face of the concrete to spall or break off. We advise waterproofing in this area. Continued rusting could eventually cause substantial damage.

Photo 2. Rust stains from crack in concrete wall at left rear.

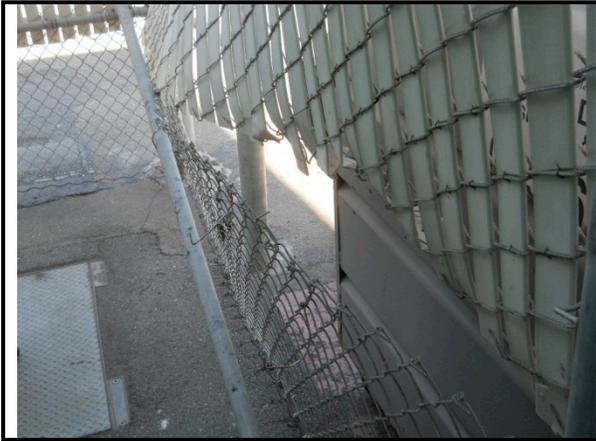
There is chain-link fencing at the rear, which encloses the back-up generator, transformer, dumpster, and HVAC equipment. The fencing is damaged and we recommend repair or replacement as needed.

Photo 3. Damaged equipment enclosure fencing at rear exterior.

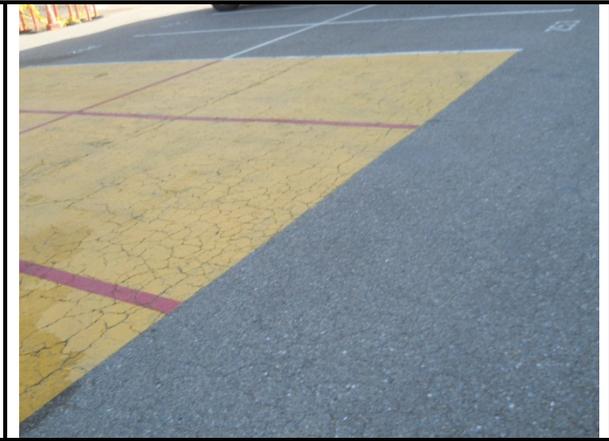
The driveways and parking areas are beginning to wear and we observed damage in several places. We recommend the driveway and parking areas be examined, repaired, and resealed by a qualified contractor. Applying top coats or new layers of asphalt over surfaces that show substantial deterioration often results in a significantly reduced service life and complete replacement of the old base rock and asphalt is often necessary to provide satisfactory performance.

Photo 4. Worn asphalt at rear.

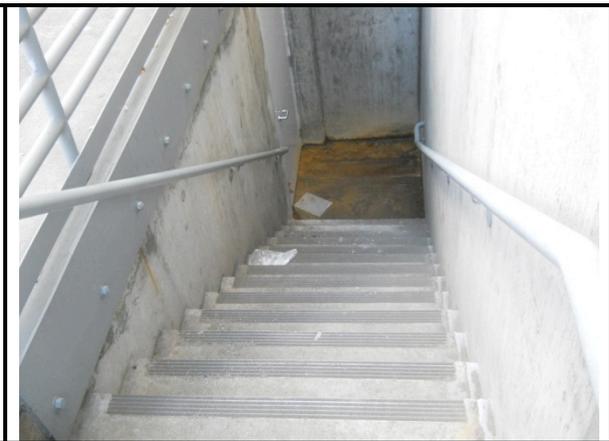
A drain in the rear stairwell is obstructed and we recommend this drain be cleared. We recommend this drain be checked periodically to ensure that the opening does not become obstructed with debris.

Photo 6. Clogged drain, standing water at bottom of rear stairwell.

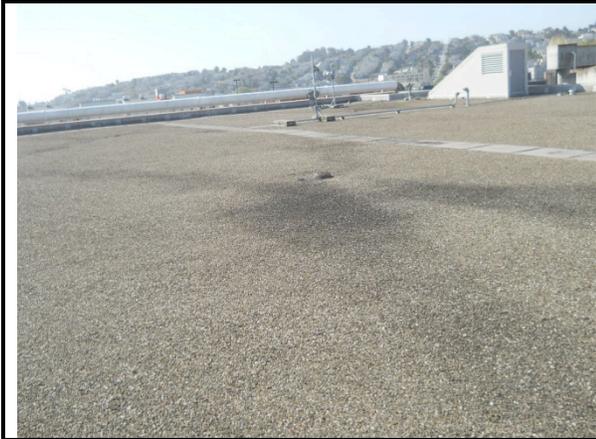
There is a gravel-surfaced, built-up roof above the fifth floor. This roof is in generally worn condition and will soon need replacement.

The roofing has been patched in several places, possibly indicating previous roof leakage and subsequent repairs. A history of patching and other roof repairs should be obtained, including the name of the repair contractor and the extent of any leaks and related damage.

Photo 7. Gravel-surfaced, built-up roof.

We recommend the need for roof surface replacement within the next few years be anticipated.

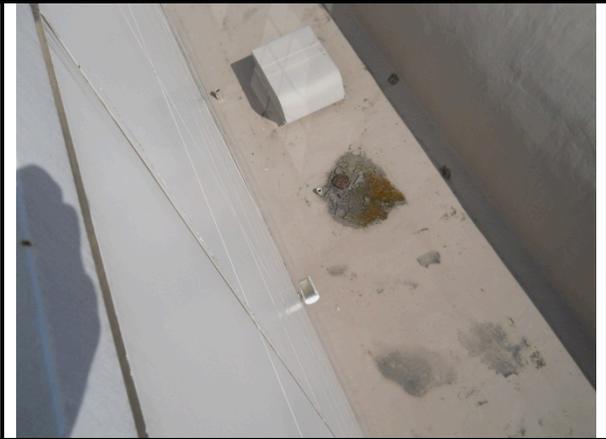
There is debris on the foam roof and we recommend the debris be removed as part of normal maintenance.

Photo 8. Debris at spray foam roofing drain.

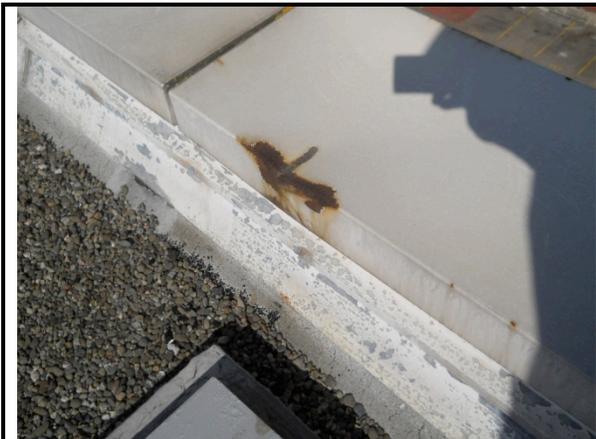
Photo 9. Rusty roof flashing.

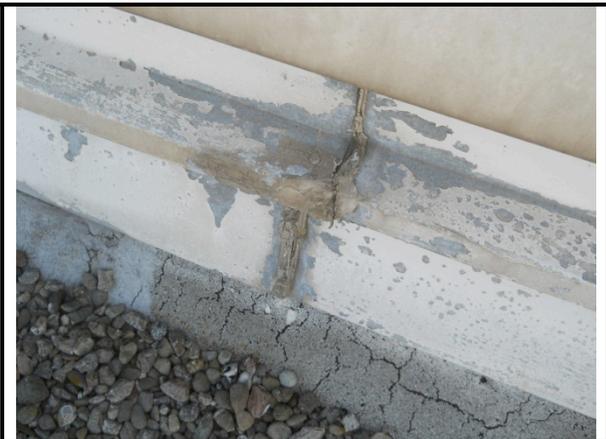
There are gaps in several of the parapet seams and metal cap seams. We recommend the roofing materials and flashings be examined and repaired as necessary by a qualified roofing contractor.

Photo 10. Gaps in roof flashing sealant.

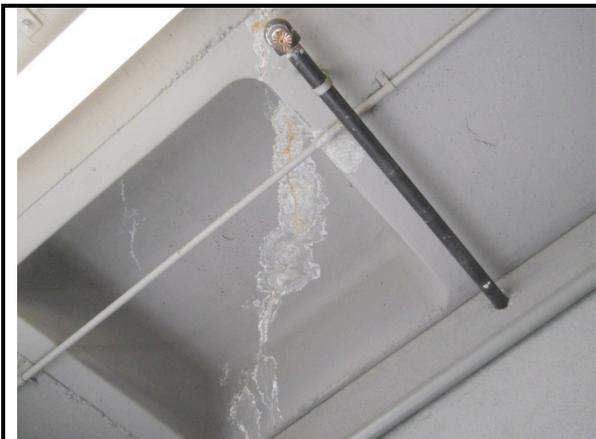
Photo 11. Stains at concrete roof crack.

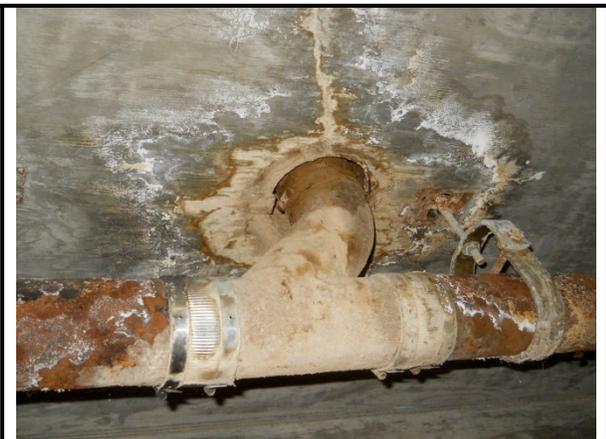
We observed no leaks in the waste piping system. Portions of the accessible waste piping in the parking garage show substantial wear and the need to replace these sections should be anticipated

Photo 12. Worn, rusty cast iron waste piping.

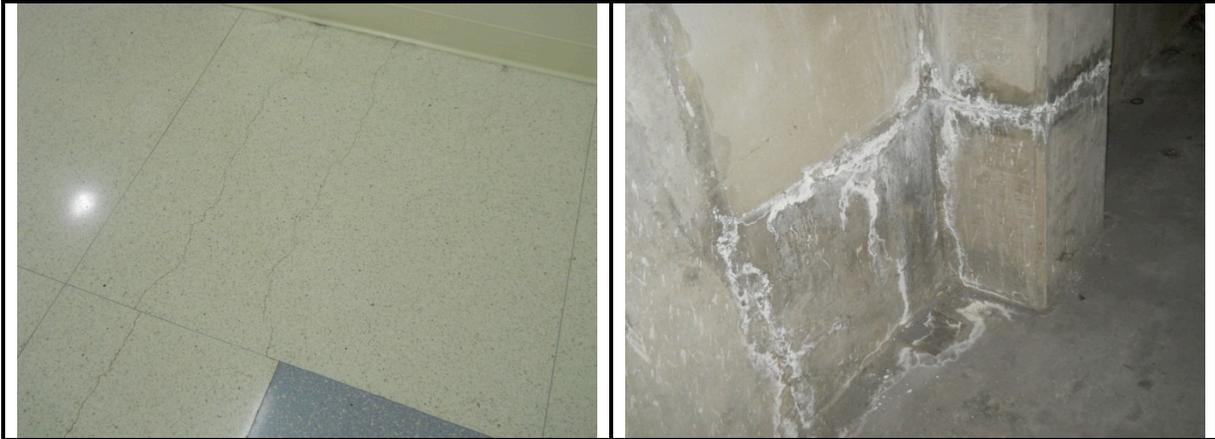
We observed efflorescence in several places on the fifth floor ceilings and on the parking garage walls. The primary source of moisture on the concrete ceilings appears to be from roof leaks. The primary source of moisture on the parking garage walls appears to be subgrade moisture.

Several of the common area terrazzo stone tiles are cracked and we recommend these areas be monitored and repaired as needed.

Photo 13. Cracked stone floor tile.

Photo 14. Efflorescence at concrete parking garage wall.
